Penile Fracture of the Crus Penis Following Taqaandan

Anne Yin, Jaffar Hussain, Jas Singh✉

Division of Urology, McGill University, Montreal, Canada

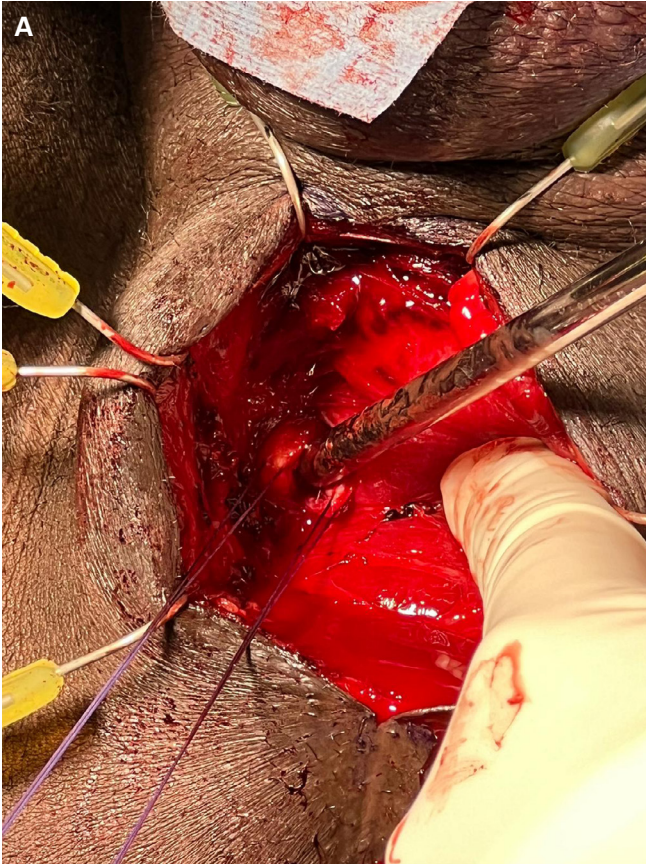
FIGURE 1.

(A) Identification of the size and location of the right-sided corporal injury. Note medial retraction of the bulbar urethra with gloved hand. **(B)** Coronal MRI image of the right corporal injury at the ventromedial location (arrow) associated with extravasation and hematoma formation (star).

Magnetic resonance imaging (MRI) of the penis demonstrated rupture of the proximal right-sided corpora cavernosum along the right crus penis. The patient underwent urgent transperineal exploration, evacuation of the perineal hematoma, and repair of an approximately 1.5 cm corporal tear (**Figure 1A and 1B**). Mobilization of the right side of the bulbar urethra was required to sufficiently identify and expose the corporal injury for repair. The tear was noted ventromedially and in close proximity to the distal bulbar urethra. Cystoscopy was

performed, which was negative for urethral injury. Repair was performed using interrupted 2–0 polydioxanone suture. At 6 weeks postoperatively, the patient was experiencing normal erectile function.
